T1154 TRANSMITTER AND R1155 RECEIVER

Originally designed and produced to provide long range communications and navigation facilities for British bomber and coastal command aircraft during the Second World War. The equipment was also used in air sea rescue launches, ground stations and ground radio vehicles. There were many variants of both T1154 and R1155 to suit the needs of the different applications.

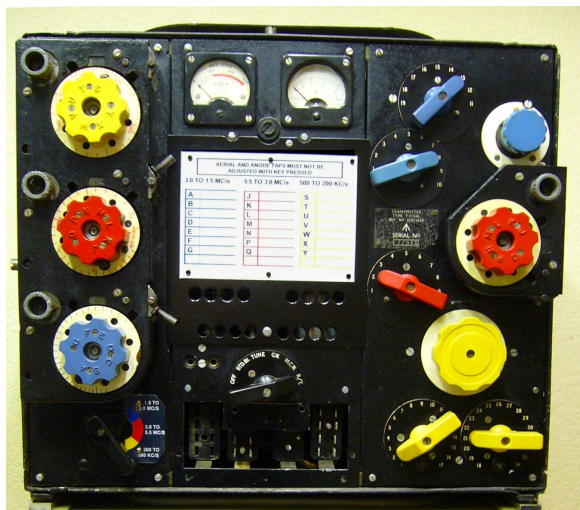
T1154L illustrated

In the aircraft the microphone and associated equipment only afforded limited voice quality, just that necessary for efficient communications. In this display the microphone is a modern desk mounted type capable of good quality and thus demonstrating the enhance qualities of the Marconi design to receiving stations.

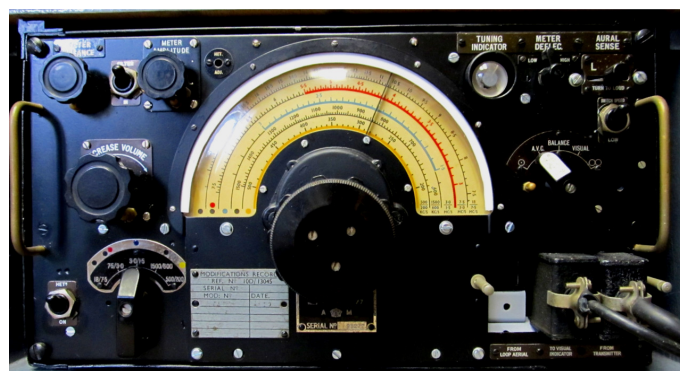
Receiver type R1155 is usually used alongside the T1154. There were many variants to suit the different applications. Airborne equipments used aluminium cases while for seaborne or ground use steel was used. By modern standards the receivers were rudimentary but being of superheterodyne design were a significant improvement over most pre-war radios.

A direction finding capability was provided by the use of a directional loop aerial permitting bearings to be taken. The twin needle visual indicator could be used for homing on a transmitter. The loop was manually rotated and often installed close to the radio operator. In the Lancaster the loop was housed within the cockpit canopy.

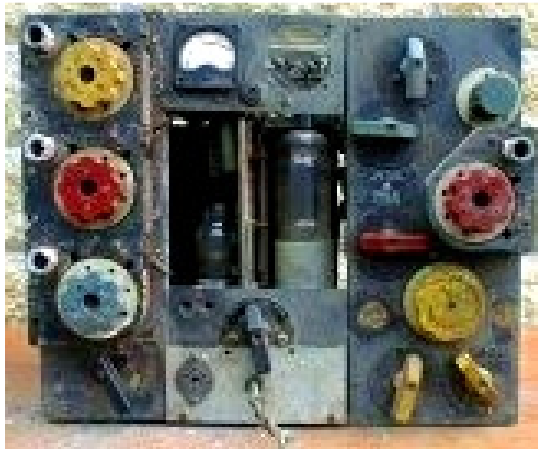
The T1154 displayed was rescued from the corner of a barn by Brian (G4LUL), it was in a very sad state and had been used by ducks as a nest box. The top covers and several pieces were missing. The picture below shows its condition prior to restoration. The components in the unit were marked 1944.

The chassis and case were corroded and the whole unit was filthy being inundated with earth, straw and dust. The unit required washing and then renovating and slowly rebuilding piece by piece. Fortunately the principle components were unbroken and with cleaning were reassembled. The case and front panel were repainted, new panels made and labels printed. New valves were purchased and a new RF ammeter found and fitted.

After cleaning most capacitors and resistors were found to be serviceable, although the rubber insulation on the wiring was perished and rewiring was needed. The Marconi pre-set tuning mechanisms were found serviceable after cleaning and lubricating.

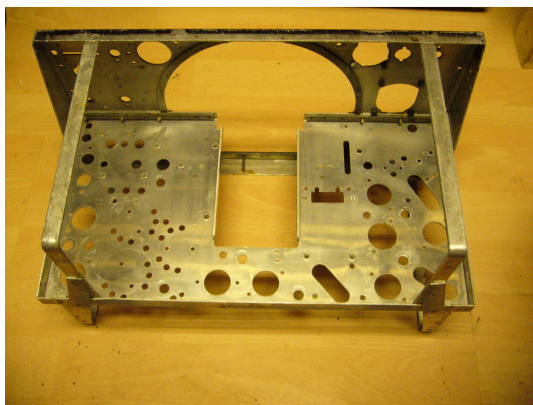
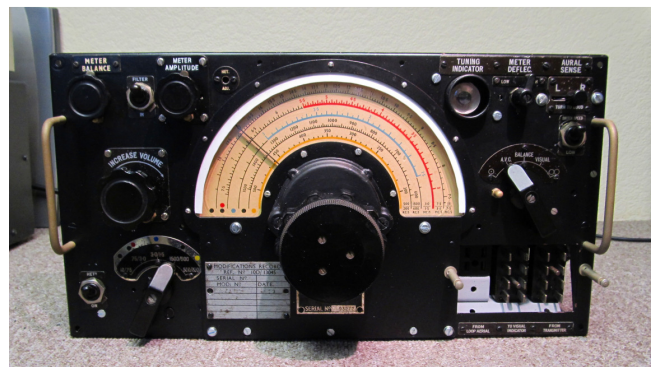
Stages in the renovation

The R1155 receiver was acquired in far better condition, however nearly all of the internal components and wiring were in an unserviceable condition. It quickly became apparent that a complete strip down would be the quickest way to renovate the equipment.

Above left chassis stripped and cleaned

Above right, reassembled

It took 12 months to renovate the receiver from start to finish.

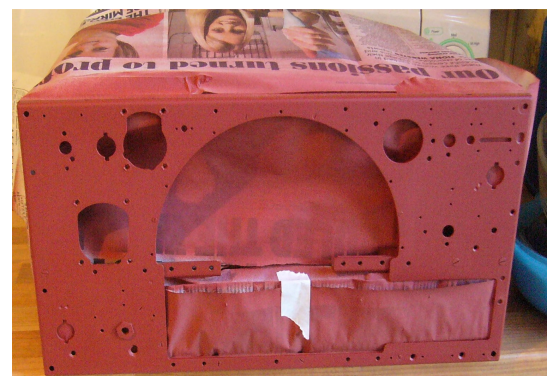
Right, first coat of etch primer.

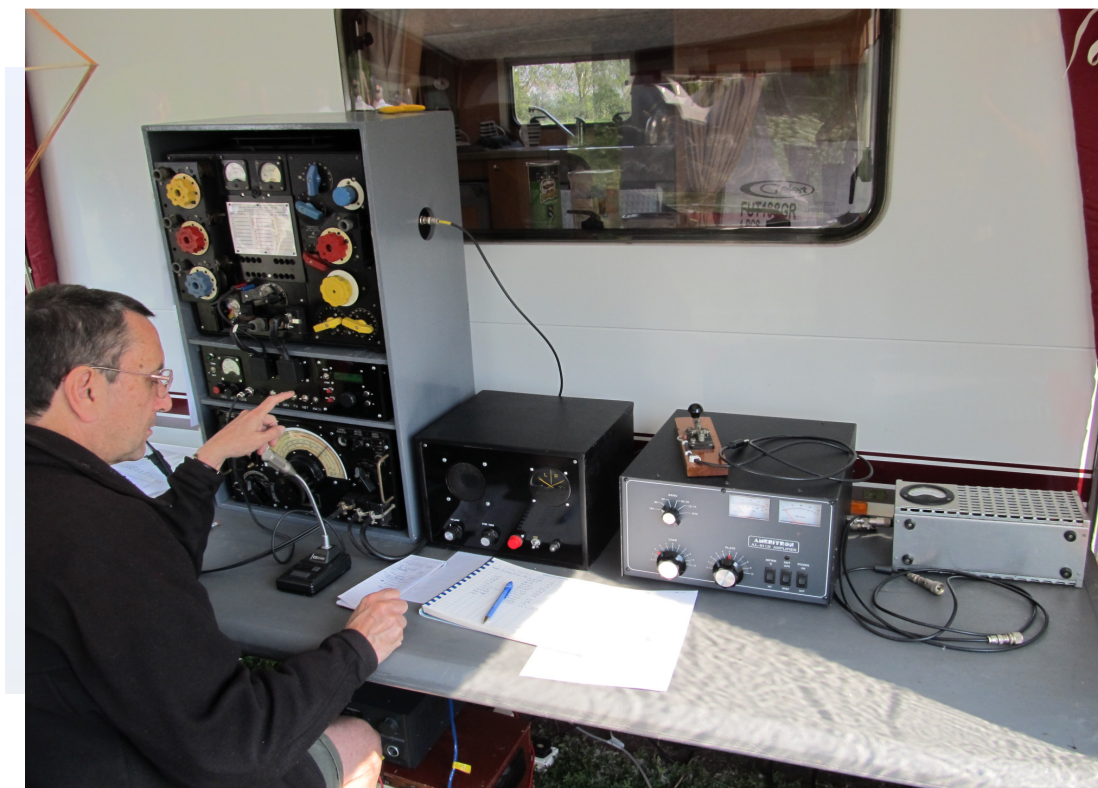
THE FINISHED STATION

To operate the transmitter under present day radio regulations and operating conditions it is necessary to improve the frequency stability. To provide this a modern synthesised frequency generator is fitted separately as an external drive for the transmitter and can be seen in this photograph located in between the T1154 and R1155. The unit also incorporates the microphone pre-amplifier and station control switching.

An additional unit on the right of the R1155 provides power, loudspeaker audio and a position for the DF visual indicator.

The high voltage supply for the transmitter is hidden under the table.
